# Complications after aortic valve repair and valve-sparing procedures

Michel Van Dyck<sup>1</sup>, David Glineur<sup>2</sup>, Laurent de Kerchove<sup>2</sup>, Gébrine El Khoury<sup>2</sup>

<sup>1</sup>Department of Acute Medicine, Division of Anesthesiology, <sup>2</sup>Cardiovascular Department, Division of Cardiothoracic and vascular Surgery, Cliniques Universitaires St-Luc, Université catholique de Louvain, Brussels, Belgium

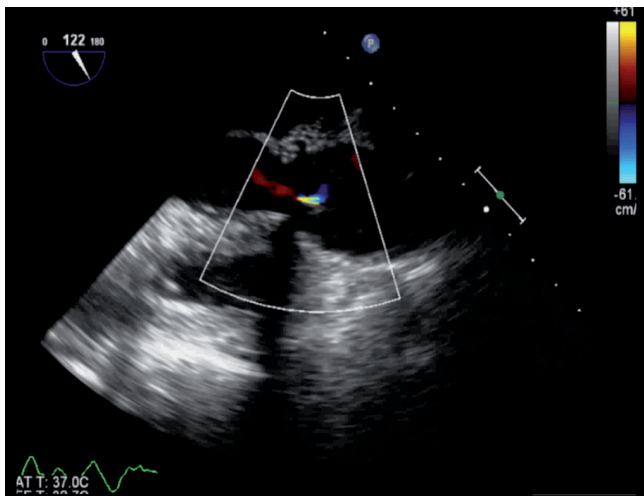
**Figure 1** Transesophageal echocardiographic midesophageal aortic valve long-axis (TEE ME AV LAX) view with color Doppler performed after aortic valve reimplantation surgery, showing mild aortic insufficiency (AI) immediately after release of the aortic cross-clamp. Note that the ECG (green trace) shows ventricular fibrillation. Magnitude of the AI at that moment, with pressure applied by the cardiopulmonary bypass (CPB) flow into the aortic root, is close to the magnitude of the AI that will be observed after CPB separation with normal hemodynamics

Immediately after aortic unclamping, TEE will disclose any residual defect of coaptation. The pressure applied by the CPB flow through the arterial cannula into the aortic root will cause regurgitation into the left ventricle if the repaired cusps do not coapt adequately (10). The severity of the regurgitation at that moment is close to the one that will be

observed after weaning of CPB (*Figure 1*).

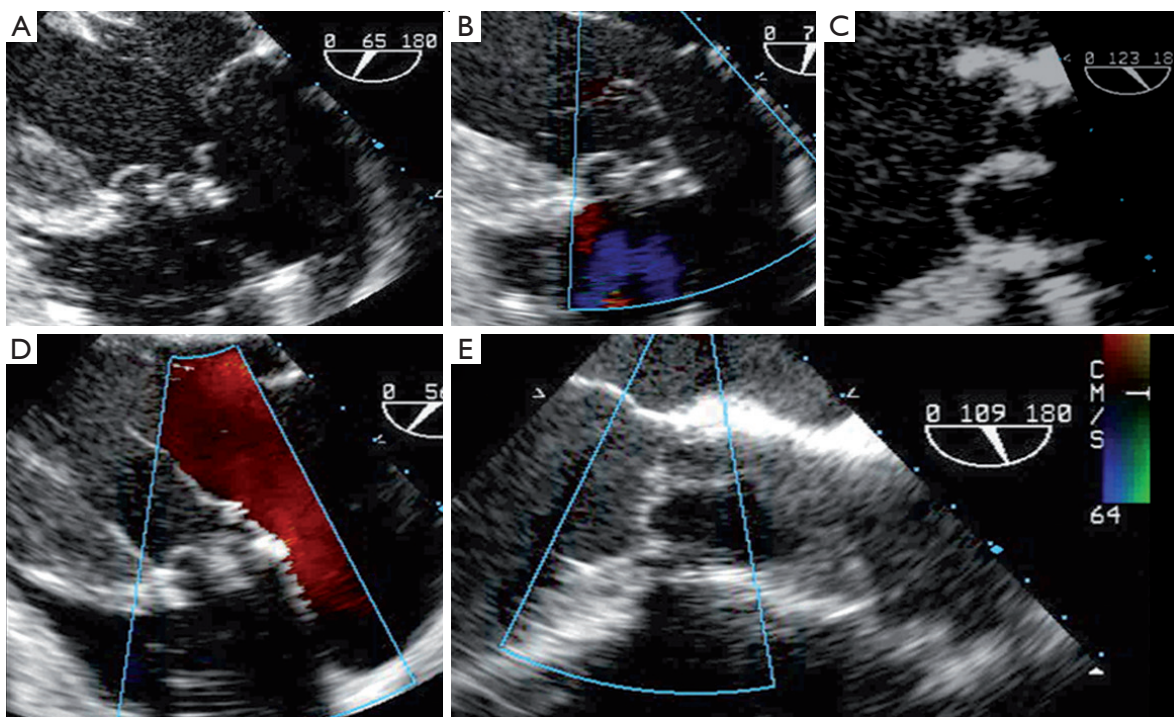
**Figure 2** (A) Transesophageal echocardiographic transgastric long-axis (TEE TG LAX) view, (B) TEE TG LAX view with color Doppler and (C) midesophageal aortic valve long-axis (ME AV LAX) view after repair of a bicuspid aortic valve and reimplantation surgery, showing a short coaptation and billowing of both cusps. Despite the absence of any AI it was decided to go back on pump and to add plication on the margin of the two cusps. (D) ME AV LAX view and (E) TG LAX view after further plication, showing a longer and higher coaptation

It has been demonstrated that the 3 most important parameters for a durable repair are: the absence of any or more than mild residual AI, a coaptation length greater than 4 mm and coaptation starting well above the plane of the aortic annulus (9). The coaptation height is the most important parameter (9,11,12) and can be measured intraoperatively with a special caliper. This effective height (eH) has been shown to correlate with the coaptation length measured with TEE in the mid-esophageal long axis view (13,14). Resuspension of the aortic commissures too low into the tube graft leads to early valve failure (11). Therefore, low coaptation observed after a valve-sparing procedure should prompt the surgeon to go back on pump and further plicate the free margin of the billowing cusp(s) in order to increase the height (15) (*Figure 2*).

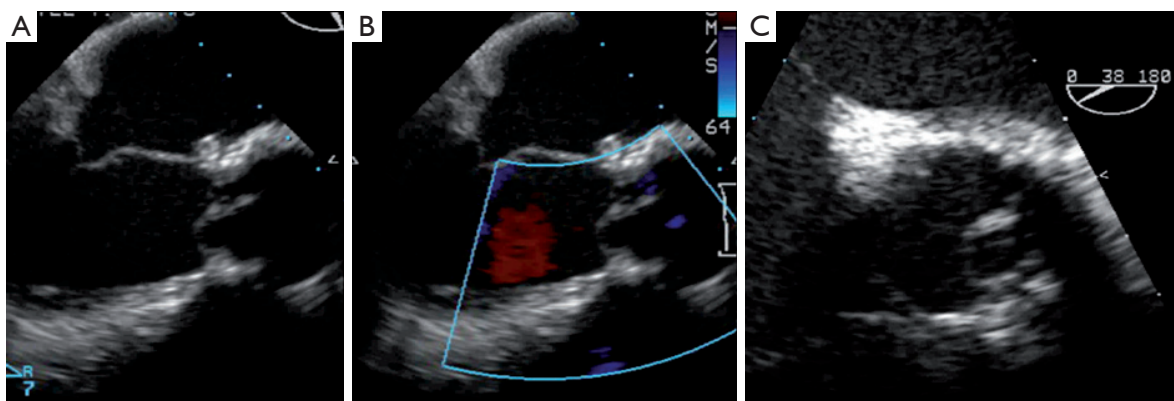
**Figure 3** Billowing of the anterior cusp of a bicuspid aortic valve after repair and reimplantation. (A and B) Transesophageal midesophageal aortic valve long-axis (TEE ME AV LAX) and (C) short-axis (ME AV SAX) view. The billowing portion of the anterior cusp appears circular in the short axis

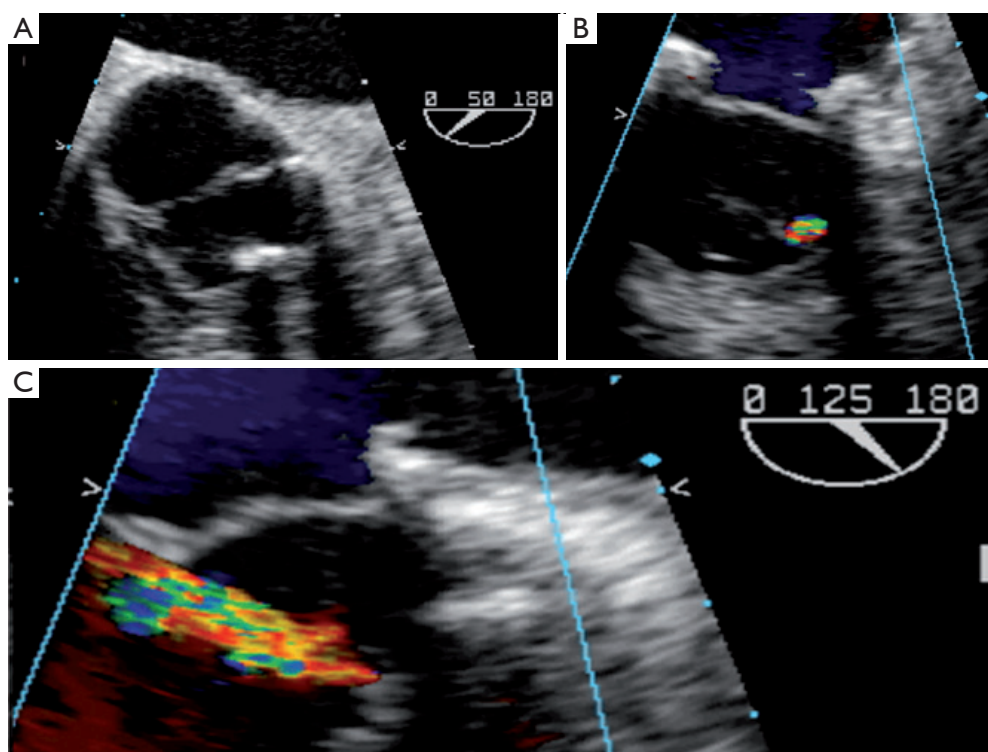
**Figure 4** Calcification of the conjoint cusp of a bicuspid aortic valve. (A) Midesophageal aortic valve short-axis (ME AV SAX) view before repair; (B) ME AV SAX and (C) long-axis (ME AV LAX) views of the aortic valve after reimplantation procedure, showing a residual perforation at the level of the removed piece of calcium

Removal of a fibrotic raphe or a piece of calcium from a cusp can leave a perforation that, if uncorrected, will appear as a residual jet originating both in the short and the long axis from the body of one of the aortic cusps (*Figure 4*). Depending on the size of the perforation, either a direct suture or a pericardial patch can be used for closure.

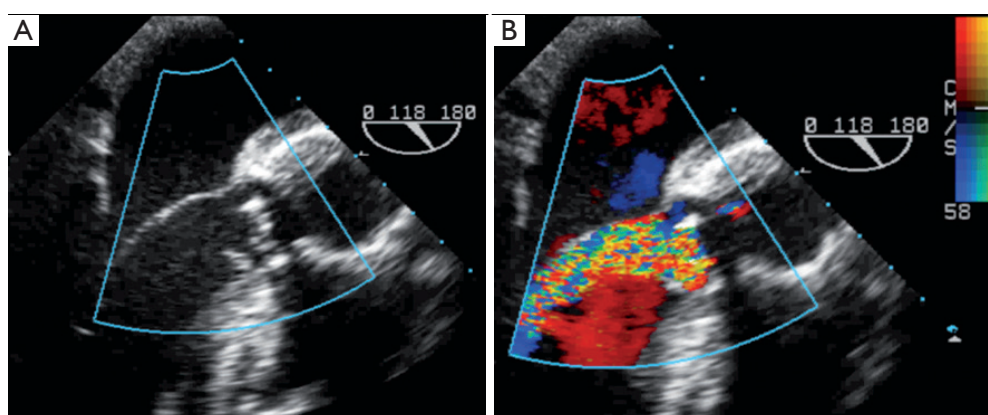
**Figure 5** Midesophageal aortic valve long-axis (ME AV LAX) view showing dehiscence of the autologous tricuspid patch used to repair a bicuspid aortic valve. This complication occurred 10 days after the valve repair, necessitating redo surgery with reattachment of the patch

and repaired the valve with a tricuspid autologous patch. Unfortunately, dehiscence of the patch occurred in the early postoperative period, necessitating an early reintervention 10 days after the initial repair (*Figure 5*). In this case, the patch was reattached. The repair lasted for 8 years, after which calcification of the valve necessitated

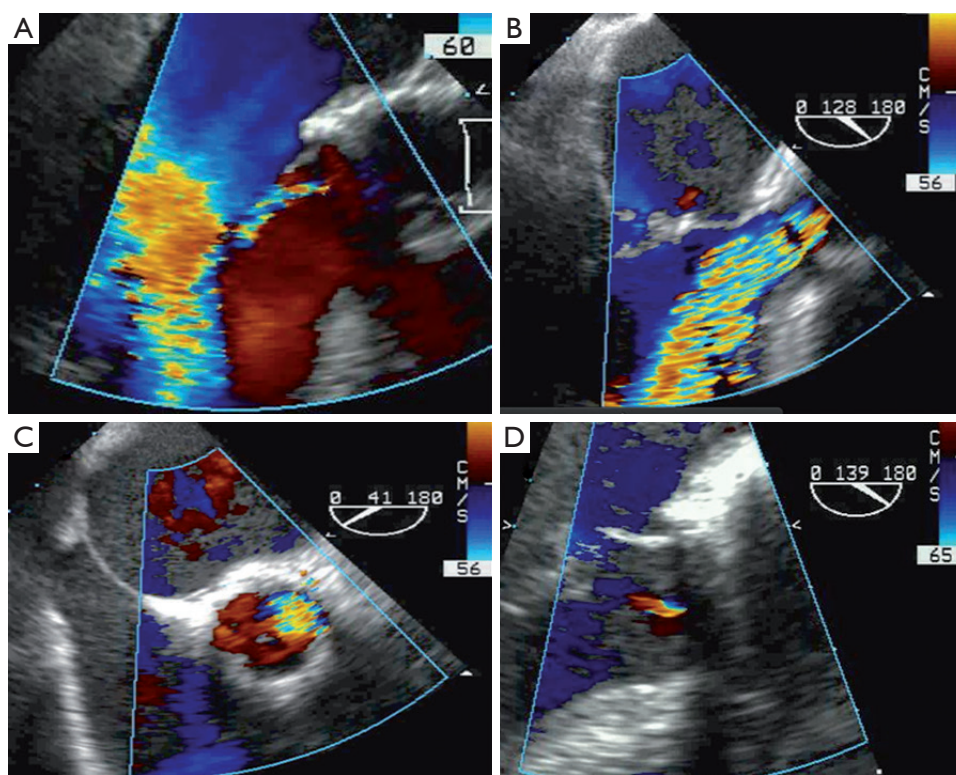
**Figure 6** Tethering of the left coronary cusp by a hemostatic stitch placed near the origin of the left main coronary artery. (A) Midesophageal aortic valve long-axis (ME AV LAX) view with color Doppler showing mild aortic insufficiency immediately after a reimplantation procedure in a tricuspid aortic valve. Persistent bleeding close to the origin of the left main coronary artery necessitated addition of a felted suture at that level. Fortuitous analysis of the aortic valve in the ME AV LAX (B) view disclosed a sudden severe aortic insufficiency. (C) Midesophageal aortic valve short-axis (ME AV SAX) view helped in localizing the origin of the jet at the level of the left coronary cusp. (D) ME AV LAX view after removal and repositioning of the causative felted stitch, showing only mild residual aortic insufficiency

the tube graft. Bleeding sometimes occurs at the level of this anastomosis. In a patient presenting continuous bleeding precluding sternal closure after a reimplantation procedure, an additional stitch was placed at the level of the left main coronary artery suture on the tube graft, correcting the problem. By chance, a rapid TEE overview before probe removal disclosed a severe AI due to retraction of the left coronary cusp by the recently added hemostatic stitch (*Figure 6*). The patient was placed back on CPB, the causal stitch was removed, rendering a normal motion to the left coronary cusp.

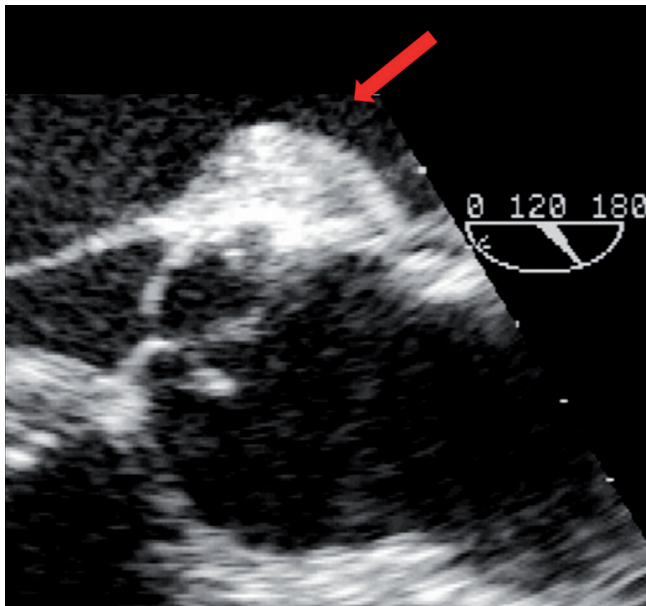
**Figure 7** Transesophageal echocardiographic midesophageal aortic valve long-axis (ME AV LAX) view showing swelling of the posterior aortic wall after aortic valve repair (red arrow). This could be due to edema or a hematoma and usually resorbs after a few days

The proximal suture of either a prosthetic valve, a subcommissural annuloplasty (SCA) or a tube graft at the level of the VAJ sometimes causes a posterior hematoma that usually resorbs after a few days (*Figure 7*).

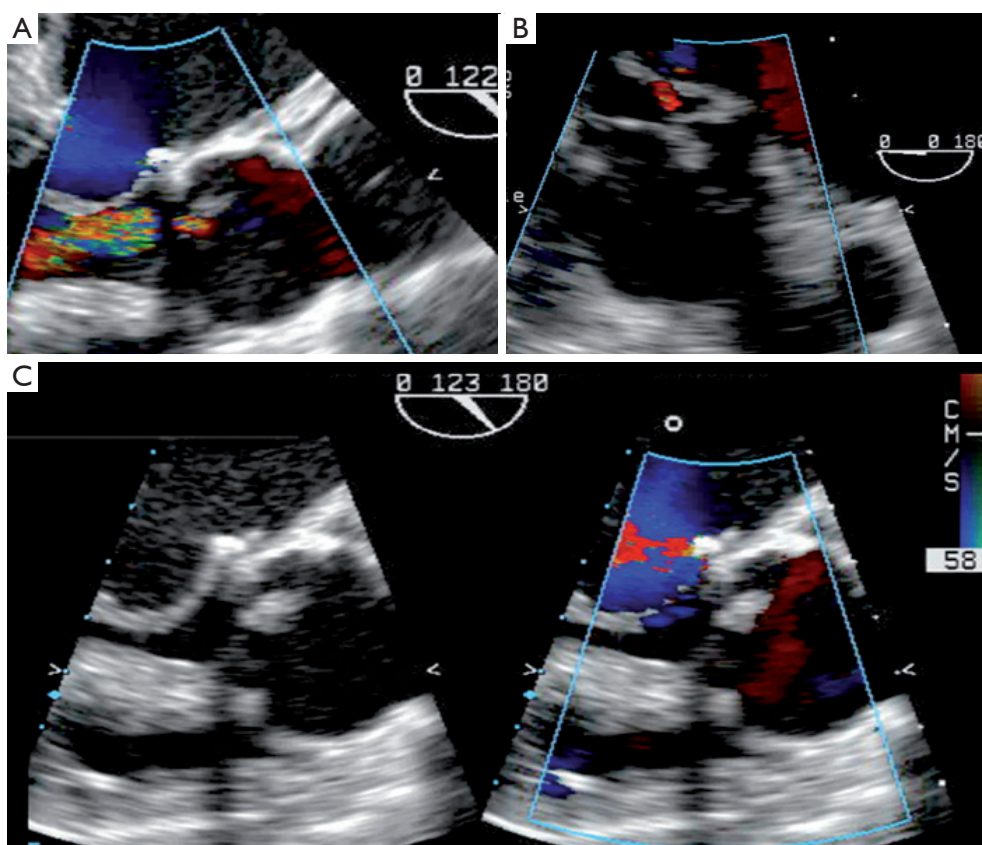
**Figure 8** Repair of a rheumatic tricuspid aortic valve associated with mitral and tricuspid valve repairs. Aortic surgery consisted of shaving of the free margins of the 3 cusps and 2 subcommissural annuloplasties (SCA) between the non-coronary cusp (NCC) and the left coronary cusp (LCC) and between the NCC and the right coronary cusp (RCC). (A) Transesophageal echocardiographic midesophageal aortic valve long-axis (TEE ME AV LAX) view with color Doppler showing an unsatisfactory result with moderate residual aortic insufficiency (AI). (B) Transesophageal echocardiographic transgastric long-axis (TEE TG LAX) view with color Doppler and (C) ME AV LAX view: after an additional annuloplasty stitch placed lower in the same 2 intercommissural triangles, the coaptation is good and the valve shows only trivial AI

Subcommissural annuloplasties (SCAs) are felted sutures applied at the mid-level of the intercommissural triangles, with the aim of reducing and stabilizing the VAJ. These sutures can also help to increase cusp coaptation (*Figure 8*).

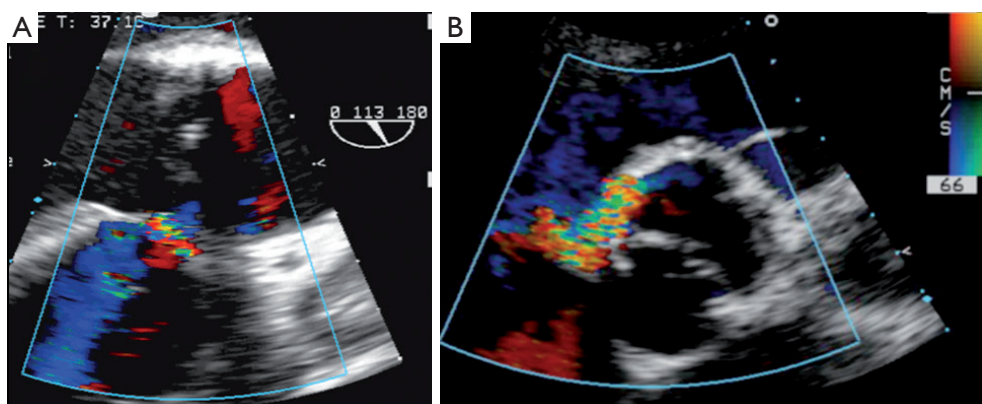
**Figure 9** Fistula between the aorta and the right ventricle after bicuspid aortic valve repair. This complication was caused by the subcommissural annuloplasty (SCA) stitch placed at the anterior commissure and was discovered at patient discharge on postoperative day 6. Midesophageal aortic valve long- (ME AV LAX) (A) and short- (ME AV SAX) (B) axis views with color Doppler on transesophageal echocardiography (TEE) performed at reoperation. Direct closure of the fistula with redo of the SCA was performed

SCAs can also provoke a tear or a fistula if the aortic wall tissue is abnormally fragile. A patient with bicuspid aortic valve presented with an aorta to right ventricle fistula at the anterior commissure 6 days after repair. At the immediate post-CPB intraoperative TEE the fistula was not observed, but at discharge transthoracic echocardiography disclosed a severe left to right shunt (*Figure 9*). The patient was immediately reoperated. The fistula was directly closed and the SCA redone.

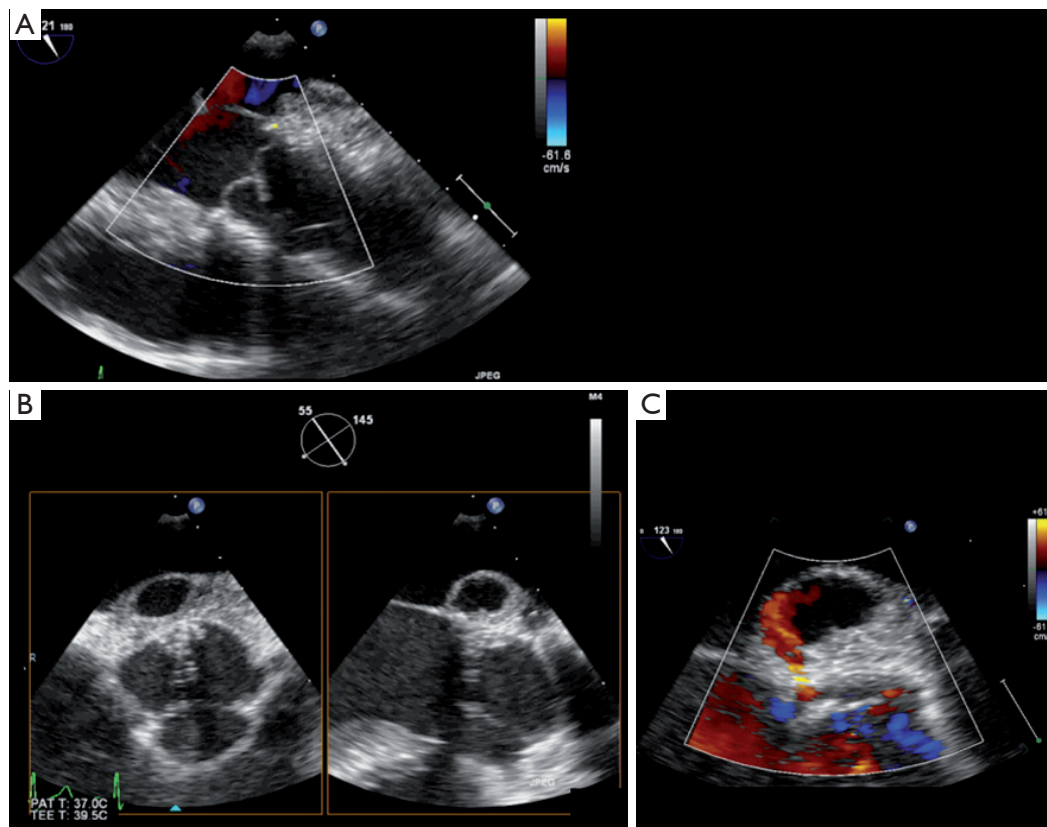
**Figure 10** Pseudoaneurysm caused by a tear in the aortic wall provoked by the subcommissural annuloplasty (SCA) stitch placed at the commissural triangle between the non- and the left coronary cusps. A. Immediate postoperative result with a posterior wall hematoma and no residual aortic insufficiency; B. A few minutes later, appearance of a growing pseudoaneurysm seen in two orthogonal planes; C. Midesophageal aortic valve long-axis (ME AV LAX) view with color Doppler showing the fistula that feeds the pseudoaneurysm. The rapid growth of the pseudoaneurysm prompted us to perform a reimplantation of the valve to exclude all fragile aortic tissues

A more severe complication of SCAs is the acute occurrence of a pseudoaneurysm. Such a pseudoaneurysm can rapidly increase due to a continuous flow from the ascending aorta

into the posterior aortic wall (*Figure 10*). We observed this complication in a case of tricuspid aortic valve repair. The surgery initially consisted of free margin plication associated with three SCAs. After unclamping, a rapidly-growing pseudoaneurysm was detected in the posterior aortic wall (non coronary sinus). At reopening of the aorta we found that the felt of the NCC/LCC SCA got through the aortic wall. Therefore we decided to perform reimplantation of the valve to exclude the abnormally fragile tissues of the aortic root.
